**Flood Control Project Maintenance
Levee Inspections**
LMA District Cover Sheet
Spring 2020 Levee Inspection Results

Lower San Joaquin Levee District

Spring 2020 Levee Inspection Results

Waterway			Bank	Unit Miles
Unit No. 01 San Joaquin River			Right	22.52
	Spring (March - May)	Summer (June - August)	(September - November) Fall	Winter (December - February)
Unit Maintenance Rating (Fall Only)				
Date of Inspection	4/21/2020 - 4/21/2020			
DWR Inspector	Corey Fujitani			
Accompanied By

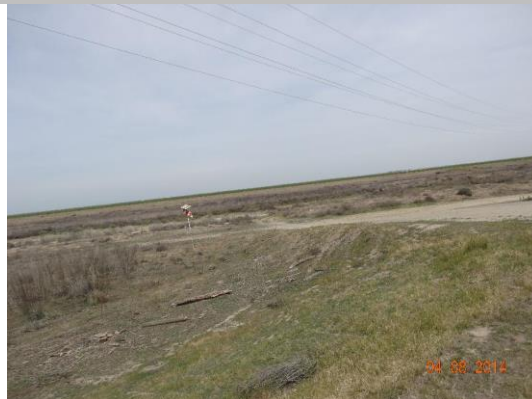
Photo 1 of 3 : UCIP_SP_2020_39505_67226.jpg

LM Start	13.59	Rating **	M	Issue No.	74
LM End	13.59	Issue Type +	En	Location *	
Category	Supplemental			GPS Latitude/Longitude	
				Start	End
Item	DWR UCIP Field Study			36.792684 °	36.792684 °
				-120.304542 °	-120.304542 °
DWR ID	19932				
Comment Code					
Inspector Comment					
DS_ID:19932 FS_ID:39505 EP_NO: N/A Repair Type: Non-Urgent Crossing Status: Indicator Found UCIP Comments: 04/08/2014 Multiple markers visible along waterward and landward sides unable to confirm how many crossings go through levee. Need to contact owner to obtain additional details on crossings. (DWR UCIP - O. Magana) FIELD_STRUCT_DESC: 6-inch natural gas pipeline of an unknown material through the levee. Pipeline extends underneath the channel. [Additional Reference(s): DWR Levee Log, 2002]. FS Date: 4/8/2014

Markers visible on waterward side.

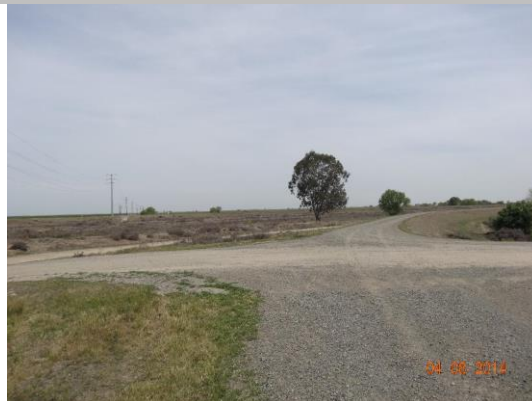
Photo 2 of 3 : UCIP_SP_2020_39505_67225.jpg

View of levee crown at crossing.

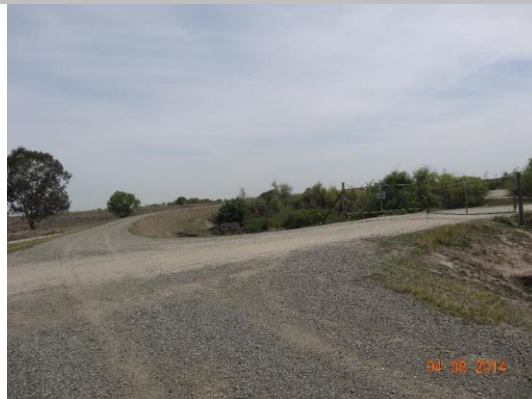
Photo 3 of 3 : UCIP_SP_2020_39505_67224.jpg

Ramp visible on landward side.

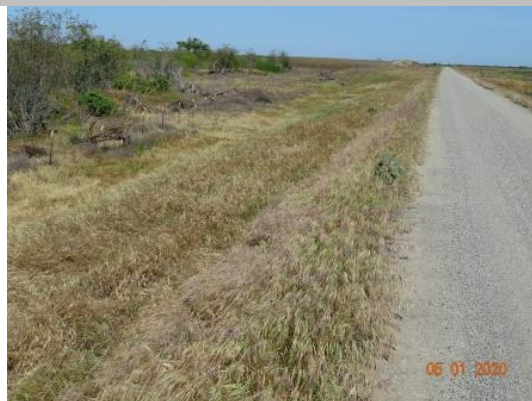
Photo 1 of 1 : SP_2020_NA0010_137_51_20200512_00040.jpg

LM Start	14.17	Rating **	U	Issue No.	51
LM End	14.95	Issue Type +	Ma	Location *	LS
Category	Earthen Levee			GPS Latitude/Longitude	
				Start	End
Item	Vegetation			36.785157 °	36.778256 °
				-120.300151 °	-120.289238 °
DWR ID	DWR_NA0010_18_s_2020_51				
Comment Code					
V1 : Control annual grass and weeds on the levee slopes and easements.					
Inspector Comment

Looking downstream along the landside slope. (Spring 2020)

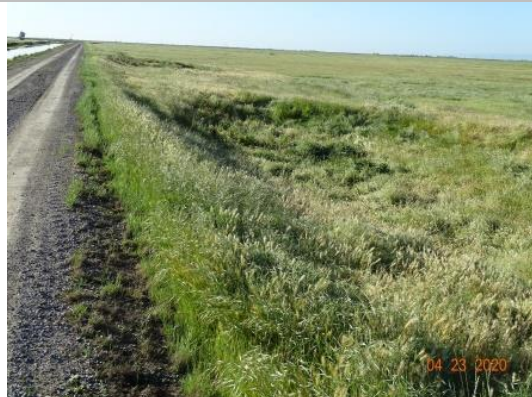
Photo 1 of 1 : SP_2020_NA0010_138_10_20200513_00067.jpg

LM Start	0.09	Rating **	U	Issue No.	10
LM End	5.51	Issue Type +	Ma	Location *	LS
Category	Earthen Levee			GPS Latitude/Longitude	
				Start	End
Item	Vegetation			37.206952 °	37.272392 °
				-120.696258 °	-120.741899 °
DWR ID	DWR_NA0010_22A_s_2020_10				
Comment Code					
V1 : Control annual grass and weeds on the levee slopes and easements.					
Inspector Comment

View of vegetation growing along the landside slope. (Spring 2020)

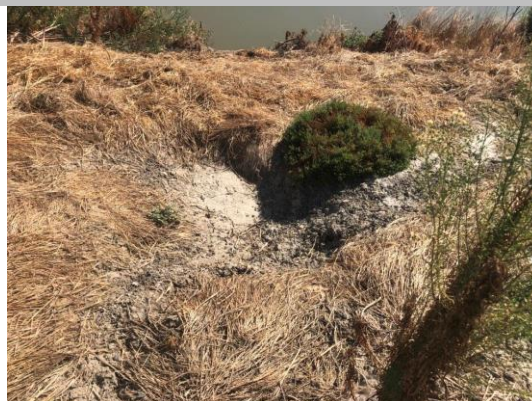
Photo 1 of 1 : SP_2020_NA0010_138_42_20200225_00051.jpg

LM Start	1.04	Rating **	M	Issue No.	42
LM End	1.04	Issue Type +	Ma	Location *	WS
Category	Supplemental			GPS Latitude/Longitude	
				Start	End
Item	DWR Erosion Survey			37.220281 °	37.220281 °
				-120.698287 °	-120.698287 °
DWR ID	NA0010U22RM5.47				
Comment Code					
Inspector Comment					
Site ID: NA0010U22RM5.47 08/28/2019: Two erosion pockets were found at the site, close to levee shoulder, and likely caused by animal activities.

Looking down at the erosion pocket.

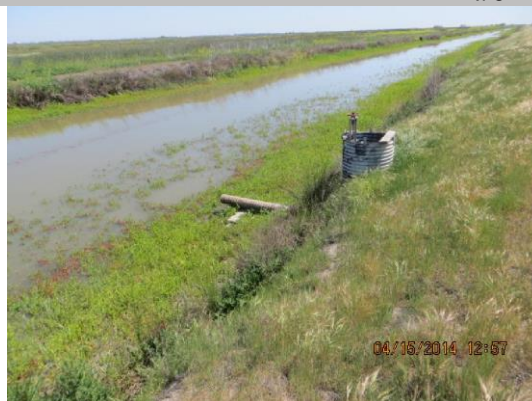
Photo 1 of 3 : UCIP_SP_2020_33733_61030.jpg

Comment Code						
Inspector Comment						
DS_ID:19936						
FS_ID:33733						
EP_NO: N/A						
Repair Type: Non-Urgent						
Crossing Status: Found						
UCIP Comments: 04/15/2014 Slide gate rusted and does not function.						
Headwall burried at LS toe. Pipe appears abandoned and if so should be done so properly. (DWR UCIP - W. Wylie)						
FIELD_STRUCT_DESC: 8-inch corrugated metal gravity irrigation pipe through the levee, 7 feet below the crown. Slide gate in a 36-inch corrugated metal pipe (CMP) riser on the waterside (WS) slope.						
Concrete headwall on the landside (LS) end. [Additional Reference(s): DWR Levee Log, 2002. USACE San Joaquin O&M Manual 601.1, 1967, (HLM 1.57)].						
FS Date: 4/15/2014

Pipe and CMP riser with slide gate visible on WS slope.

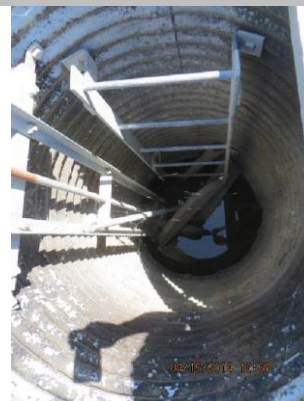
Photo 2 of 3 : UCIP_SP_2020_33733_61029.jpg

LM Start	1.57	Rating **	M	Issue No.	261 (cont)
LM End	1.57	Issue Type +	En	Location *	
Category	Supplemental		GPS Latitude/Longitude		
			Start	End	
Item	DWR UCIP Field Study		37.227588 °	37.227588 °	
			-120.700945 °	-120.700945 °	
DWR ID	19936

Inside CMP riser on WS shoulder.

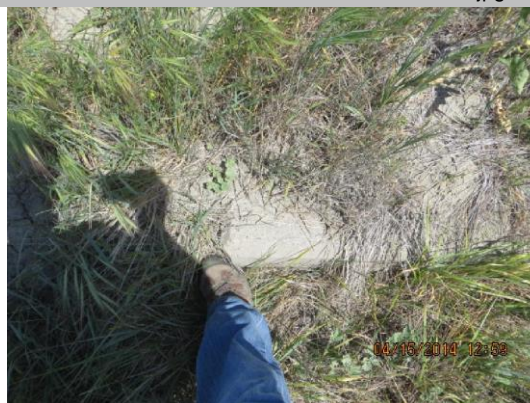
Photo 3 of 3 : UCIP_SP_2020_33733_61028.jpg

Buried concrete headwall on LS toe.

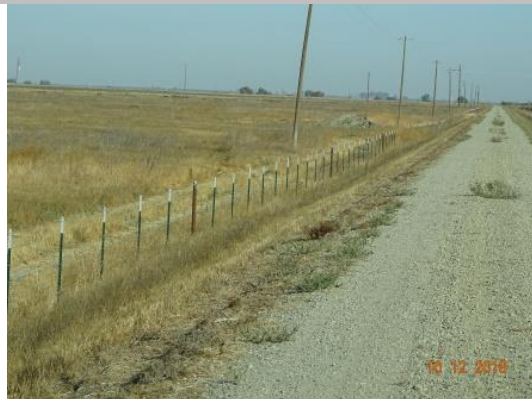
Photo 1 of 1 : SP_2020_NA0010_138_28_20200225_00025.jpg

LM Start	1.75	Rating **	M	Issue No.	28
LM End	2.60	Issue Type +	En	Location *	LS
Category	Earthen Levee			GPS Latitude/Longitude	
				Start	End
Item	Encroachments			37.230585 °	37.242371 °
				-120.702045 °	-120.706371 °
DWR ID	DWR_NA0010_22A_f_2018_28				
Comment Code					
FE : Fence					
Inspector Comment					
A fence is located along the landside toe.

View of fence along landside toe. (Fall 2018)

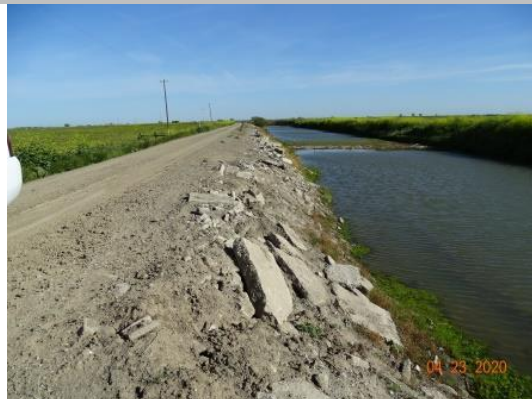
Photo 1 of 2 : SP_2020_NA0010_138_41_20200513_00069.jpg

LM Start	2.65	Rating **	A/W	Issue No.	41
LM End	2.66	Issue Type +	Ma	Location *	WS
Category	Supplemental			GPS Latitude/Longitude	
				Start	End
Item	DWR Erosion Survey			37.242595 °	37.242595 °
				-120.706470 °	-120.706470 °
DWR ID	NA0010U22RM3.87				
Comment Code					
Inspector Comment					
Site ID: NA0010U22RM3.87 04/23/2020: Fill and concrete has been placed on the waterside shoulder and slope. Monitor. 09/12/2019: The erosion has cut into the levee prism and damaged almost half of the levee. The livestock traffic has likely caused the erosion.

View of repaired shoulder and slope. (Spring 2020)

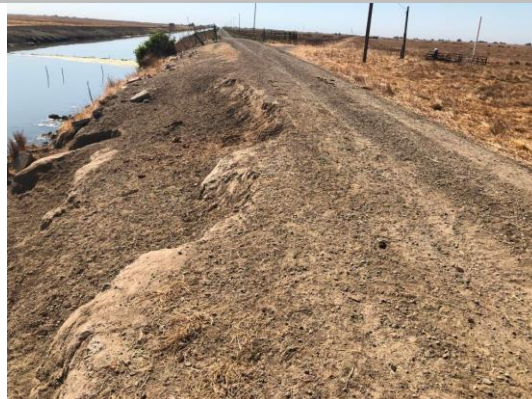
Photo 2 of 2 : SP_2020_NA0010_138_41_20200225_00048.jpg

Looking down at the erosion pocket.

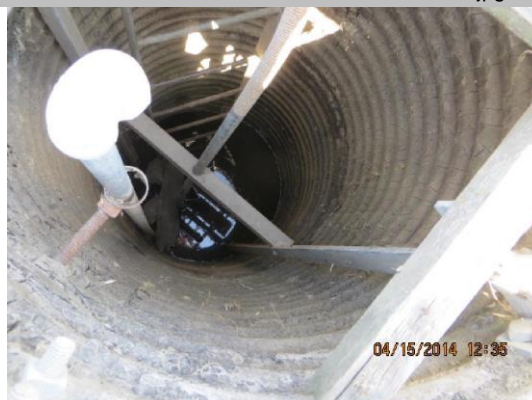
Photo 2 of 3 : UCIP_SP_2020_33732_61024.jpg

Inside CMP riser on WS shoulder.

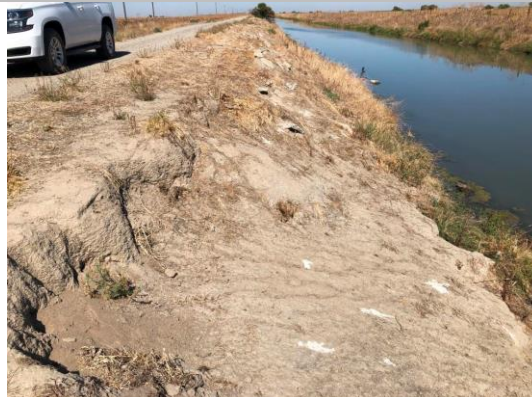
Photo 2 of 2 : SP_2020_NA0010_138_38_20200225_00039.jpg

LM Start	2.96	Rating **	A/W	Issue No.	38 (cont)
LM End	2.97	Issue Type +	Ma	Location *	WS
Category	Supplemental			GPS Latitude/Longitude	
				Start	End
Item	DWR Erosion Survey			37.246408 °	37.246408 °
				-120.709197 °	-120.709197 °
DWR ID	NA0010U22RM3.56

Looking down at the erosion pocket.

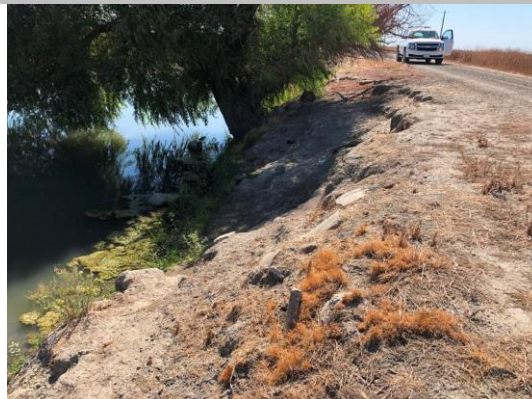
Photo 1 of 1 : SP_2020_NA0010_138_36_20200225_00036.jpg

LM Start	3.14	Rating **	U	Issue No.	36
LM End	3.15	Issue Type +	Ma	Location *	WS
Category	Supplemental			GPS Latitude/Longitude	
				Start	End
Item	DWR Erosion Survey			37.248257 °	37.248257 °
				-120.711547 °	-120.711547 °
DWR ID	NA0010U22RM3.38

09/12/2019: The erosion has damaged the entire levee slope. Livestock activity likely has caused the erosion.

Close-up view of the erosion. Note the willow tree near the site.

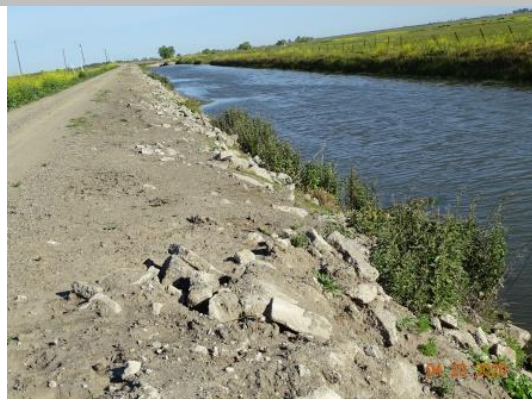
Photo 1 of 1 : SP_2020_NA0010_138_35_20200513_00073.jpg

LM Start	3.47	Rating **	U	Issue No.	35
LM End	3.47	Issue Type +	Ma	Location *	WS
Category	Earthen Levee			GPS Latitude/Longitude	
				Start	End
Item	Animal Control			37.251621 °	37.251621 °
				-120.715649 °	-120.715649 °
DWR ID	DWR_NA0010_22A_f_2018_35				
Comment Code					
A2 : Repair the levee slope damaged by livestock and prevent large animal access.					
Inspector Comment					
Waterside slope erosion is from livestock activity. Slope stabilized with borken concrete. Concrete with rebar in it should be removed.

Fill and concrete placed on the waterside slope. Rebar should be removed for safety. (Spring 2020)

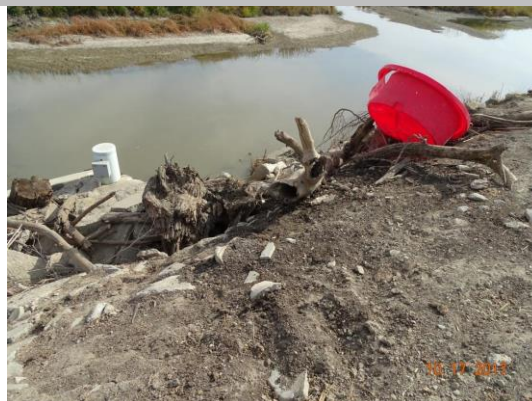
Photo 1 of 1 : SP_2020_NA0010_138_13_20200225_00014.jpg

LM Start	3.81	Rating **	M	Issue No.	13
LM End	3.81	Issue Type +	Ma	Location *	WS
Category	Earthen Levee			GPS Latitude/Longitude	
				Start	End
Item	Encroachments			37.255199 °	37.255199 °
				-120.720094 °	-120.720094 °
DWR ID	DWR_NA0010_22A_f_2017_13				
Comment Code					
TR : Tree or limb					
Inspector Comment

Looking northeast at the waterside slope.

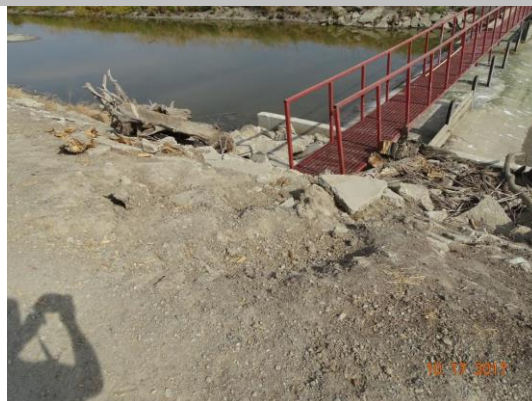
Photo 1 of 1 : SP_2020_NA0010_138_14_20200225_00015.jpg

LM Start	3.82	Rating **	M	Issue No.	14
LM End	3.82	Issue Type +	Ma	Location *	WS
Category	Earthen Levee			GPS Latitude/Longitude	
				Start	End
Item	Slope Stability			37.255239 °	37.255239 °
				-120.720142 °	-120.720142 °
DWR ID	DWR_NA0010_22A_f_2017_14				
Comment Code					
S1 : Repair slope instability.					
Inspector Comment

Looking northeast at the waterside slope. (Fall 2017)

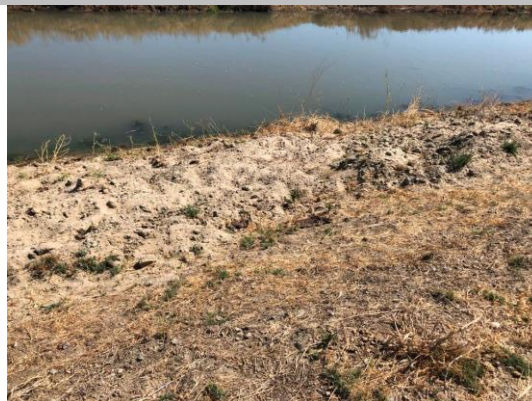
Photo 1 of 1 : SP_2020_NA0010_138_26_20200225_00022.jpg

LM Start	4.26	Rating **	A/W	Issue No.	26
LM End	4.30	Issue Type +	Ma	Location *	WS
Category	Supplemental			GPS Latitude/Longitude	
				Start	End
Item	DWR Erosion Survey			37.260111 °	37.260111 °
				-120.725900 °	-120.725900 °
DWR ID	NA0010U22RM2.25				
Comment Code					
Inspector Comment					
Site ID: NA0010U22RM2.25 09/12/2019: Erosion has developed into the lower levee slope. Loose material was observed at the site.

Looking down at the erosion pocket.

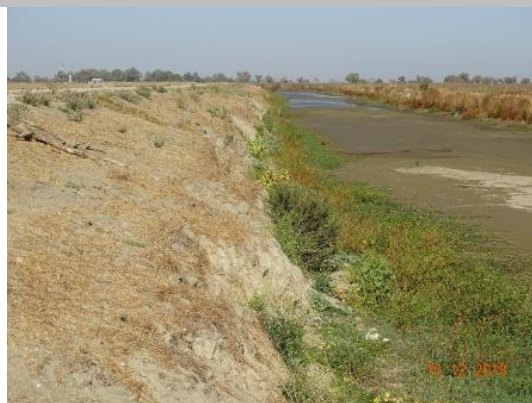
Photo 1 of 1 : SP_2020_NA0010_138_37_20200225_00038.jpg

LM Start	4.28	Rating **	U	Issue No.	37
LM End	5.11	Issue Type +	Ma	Location *	WS
Category	Earthen Levee			GPS Latitude/Longitude	
				Start	End
Item	Erosion / Bank Caving			37.260111 °	37.268135 °
				-120.725900 °	-120.737130 °
DWR ID	DWR_NA0010_22A_f_2018_37				
Comment Code					
E2 : Schedule repair of erosion site prior to the next inspection.					
Inspector Comment					
Erosion is cutting into the waterside slope.

View of waterside slope looking downstream. (Fall 2018)

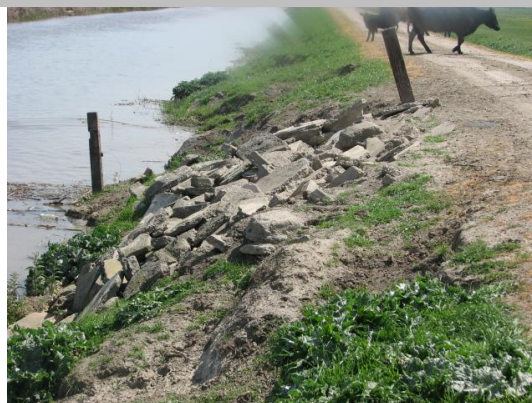
Photo 1 of 1 : SP_2020_NA0010_138_8_20200225_00008.jpg

LM Start	4.87	Rating **	A/W	Issue No.	8
LM End	4.87	Issue Type +	Ma	Location *	WS
Category	Earthen Levee			GPS Latitude/Longitude	
				Start	End
Item	Animal Control			37.265813 °	37.265813 °
				-120.733748 °	-120.733748 °
DWR ID	DWR_NA0010_22A_f_2016_8				
Comment Code					
A2 : Repair the levee slope damaged by livestock and prevent large animal access.					
Inspector Comment					
Levee damage caused by animal traffic. Several sites repaired with broken concrete.

Looking downstream at repaired site with concrete rubble on waterward slope and shoulder. (Spring 2018)

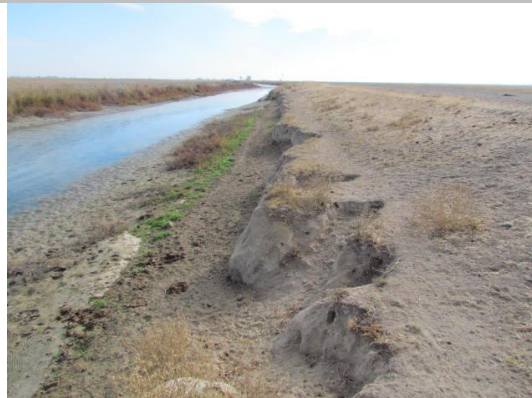
Photo 1 of 1 : SP_2020_NA0010_138_6_20200225_00003.jpg

LM Start	5.12	Rating **	M	Issue No.	6
LM End	5.49	Issue Type +	Ma	Location *	WS
Category	Earthen Levee			GPS Latitude/Longitude	
				Start	End
Item	Animal Control			37.268236 °	37.272262 °
				-120.737210 °	-120.741778 °
DWR ID	DWR_NA0010_22A_s_2012_6				
Comment Code					
A2 : Repair the levee slope damaged by livestock and prevent large animal access.					
Inspector Comment					
Slope damage is caused by livestock on waterside toe.

Looking southeast at livestock erosion on waterward toe.

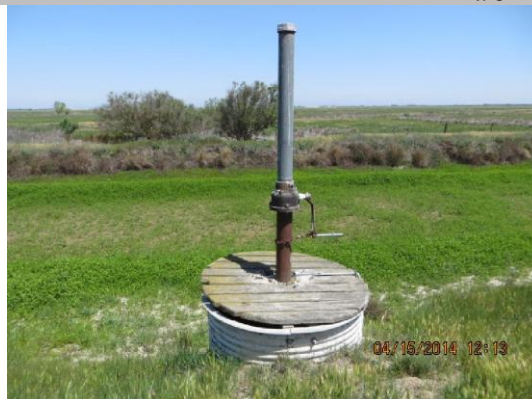
Photo 1 of 3 : UCIP_SP_2020_39536_61022.jpg

LM Start	5.48	Rating **	M	Issue No.	263	
LM End	5.48	Issue Type +	En	Location *		
Category	Supplemental			GPS Latitude/Longitude		
				Start	End	
Item	DWR UCIP Field Study			37.272079 °	37.272079 °	
				-120.741575 °	-120.741575 °	
DWR ID	19938

Comment Code						
Inspector Comment						
DS_ID:19938 FS_ID:39536 EP_NO: N/A Repair Type: Non-Urgent Crossing Status: Found UCIP Comments: 04/15/2014 Need to contact owner. Pipe silted in on LS toe. Appears abandoned and if so should be done so properly. (DWR UCIP - W. Wylie) FIELD_STRUCT_DESC: 48-inch corrugated metal irrigation siphon pipe through the levee, 10 feet below the crown. Slide gate in a 60-inch corrugated metal pipe (CMP) riser on the waterside (WS) slope. Concrete headwall on the landside (LS) end. WS end capped with a 0.25-inch steel plate. [Additional Reference(s): DWR Levee Log, 2002. USACE San Joaquin O&M Manual 601.1, 1967, (HLM 5.48)]. FS Date: 4/15/2014

Slidegate inside riser on WS shoulder.

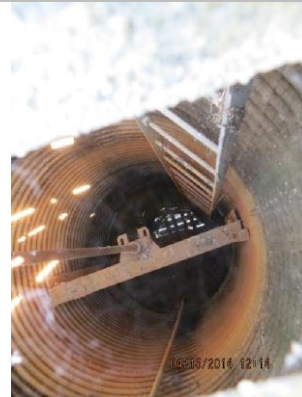
Photo 2 of 3 : UCIP_SP_2020_39536_61021.jpg

Inside riser on WS shoulder.

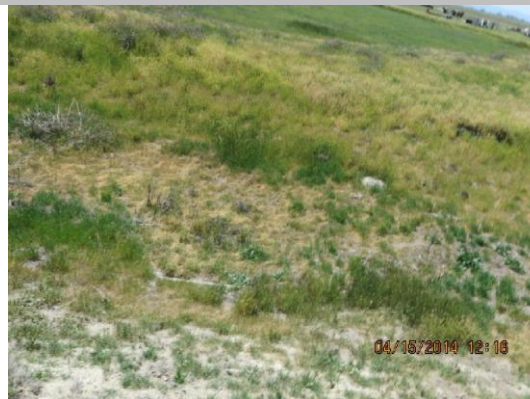
Photo 3 of 3 : UCIP_SP_2020_39536_61020.jpg

Buried headwall on LS toe.

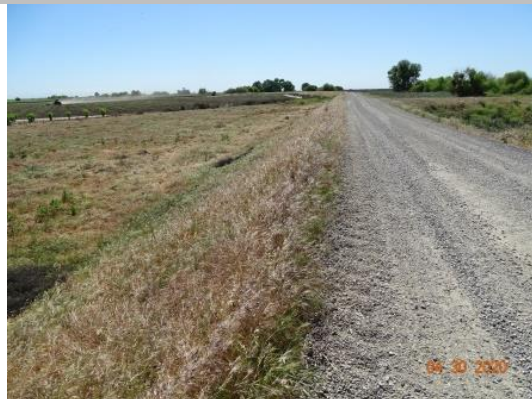
Photo 1 of 1 : SP_2020_NA0010_139_31_20200513_00043.jpg

LM Start	0.02	Rating **	U	Issue No.	31
LM End	0.57	Issue Type +	Ma	Location *	LS
Category	Earthen Levee			GPS Latitude/Longitude	
				Start	End
Item	Vegetation			36.774154 °	36.774052 °
				-120.283375 °	-120.275361 °
DWR ID	DWR_NA0010_23_s_2020_31				
Comment Code					
V1 : Control annual grass and weeds on the levee slopes and easements.					
Inspector Comment

View of the landside slope looking upstream. (Spring 2020)

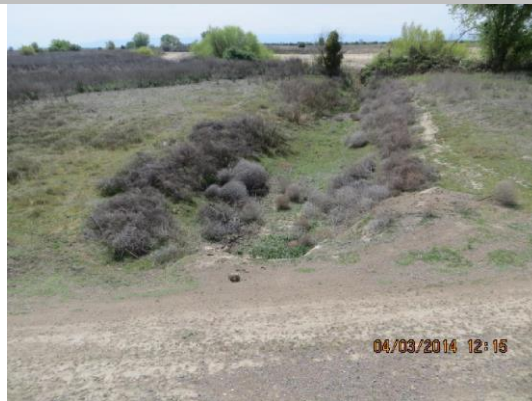
Photo 1 of 3 : UCIP_SP_2020_39537_59860.jpg

Comment Code					
Inspector Comment					
DS_ID:19945 FS_ID:39537 EP_NO: N/A Repair Type: Non-Urgent Crossing Status: Found UCIP Comments: 04/03/2014 Excessive vegetation at inlet-- recommend clearing. (DWR UCIP - W. Wylie) FIELD_STRUCT_DESC: 30-inch by 30-inch square reinforced concrete box gravity drainage culvert through the levee, 13 feet below the crown. Flap gate on the waterside (WS) end. Concrete headwall on the landside (LS) end. Concrete U-shaped headwall on the WS end. (Plans to construct a new discharge structure and to rehabilitate one existing diversion structure to return intercepted seepage to the San Joaquin River authorized under Permit No. 13085, 1981 - Diener, Dry River Farms). [Additional Reference(s): DWR Levee Log, 2002. USACE San Joaquin O&M Manual 601.1, 1967, (HLM 0.21)]. FS Date: 4/3/2014

Concrete headwall on WS toe at channel.

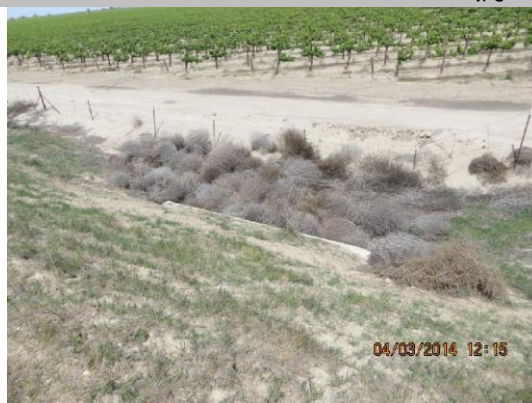
Photo 3 of 3 : UCIP_SP_2020_39537_59861.jpg

Concrete headwall at LS toe. Excess vegetation buildup at inlet.

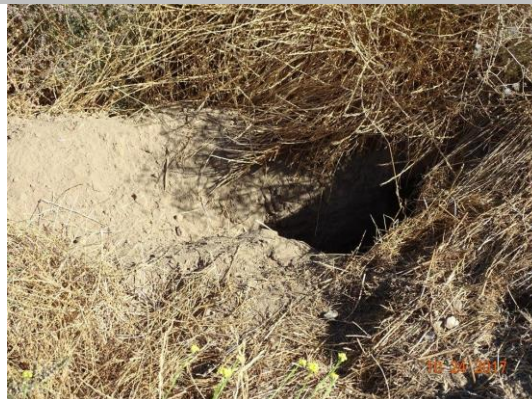
Photo 1 of 1 : SP_2020_NA0010_139_26_20200225_00006.jpg

LM Start	1.09	Rating **	U	Issue No.	26
LM End	1.09	Issue Type +	Ma	Location *	LS
Category	Earthen Levee			GPS Latitude/Longitude	
				Start	End
Item	Animal Control			36.772743 °	36.772743 °
				-120.266800 °	-120.266800 °
DWR ID	DWR_NA0010_23_f_2017_26				
Comment Code					
A3 : No rodents visible, but rodent burrows visible; need to backfill and compact or grout burrows.					
Inspector Comment					
Need to repair the large rodent hole on the landside slope.

Looking at the landside slope.

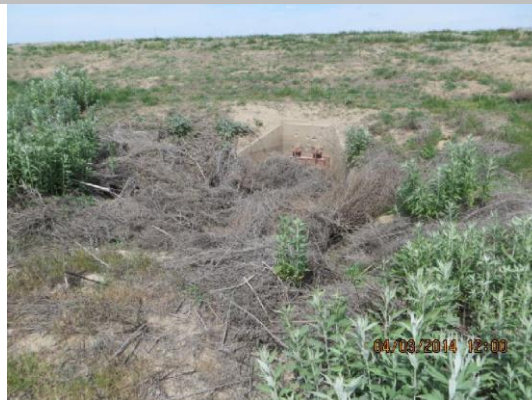
Photo 2 of 3 : UCIP_SP_2020_39538_59857.jpg

Flapgate on Concrete headwall at WS toe.

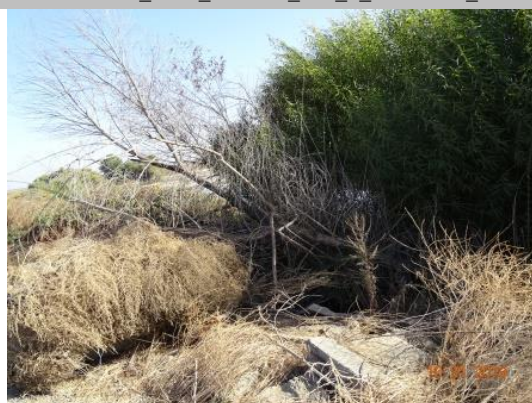
Photo 1 of 1 : SP_2020_NA0010_139_1_20200225_00001.jpg

LM Start	1.91	Rating **	M	Issue No.	1
LM End	1.91	Issue Type +	Ma	Location *	WS
Category	Earthen Levee			GPS Latitude/Longitude	
				Start	End
Item	Encroachments			36.772943 °	36.772943 °
				-120.253511 °	-120.253511 °
DWR ID	DWR_NA0010_23_s_2015_1				
Comment Code					
TR : Tree or limb					
Inspector Comment					
There is a downed tree on the waterside slope.

View of fallen tree on the waterside slope. (Fall 2019)

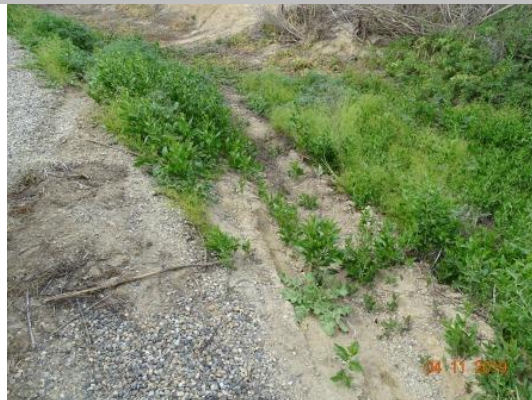
Photo 1 of 1 : SP_2020_NA0010_139_62_20200225_00014.jpg

LM Start	4.85	Rating **	M	Issue No.	62
LM End	4.85	Issue Type +	Ma	Location *	LS
Category	Earthen Levee			GPS Latitude/Longitude	
				Start	End
Item	Slope Stability			36.789489 °	36.789489 °
				-120.220403 °	-120.220403 °
DWR ID	DWR_NA0010_23_s_2019_62				
Comment Code					
S3 : Repair the levee slope damaged by vehicle traffic and prevent access where possible.					
Inspector Comment

View of damage to landside slope by vehicle traffic looking downstream. (Spring 2019)

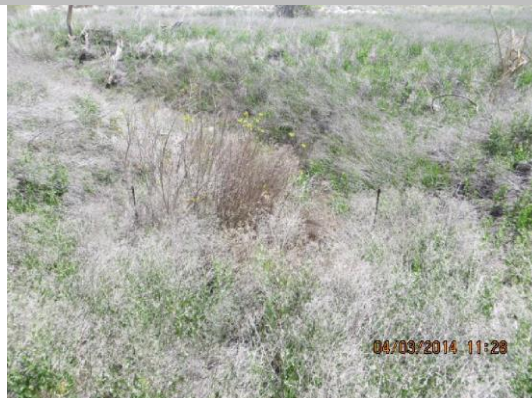
Photo 2 of 3 : UCIP_SP_2020_39540_59847.jpg

Heavy vegetation in outlet/channel on WS toe.

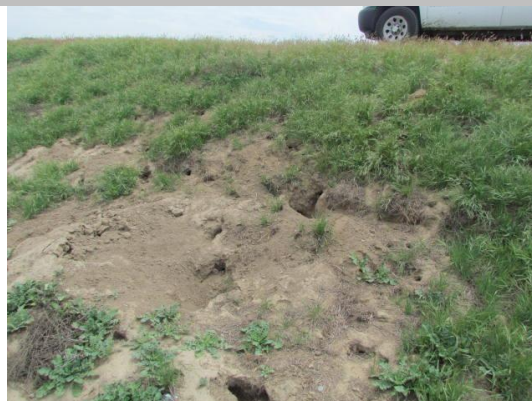
Photo 1 of 1 : SP_2020_NA0010_139_5_20200225_00003.jpg

LM Start	5.68	Rating **	U	Issue No.	5
LM End	5.68	Issue Type +	Ma	Location *	LS
Category	Earthen Levee			GPS Latitude/Longitude	
				Start	End
Item	Animal Control			36.791981 °	36.791981 °
				-120.206274 °	-120.206274 °
DWR ID	DWR_NA0010_23_s_2012_5				
Comment Code					
A1 : Exterminate rodents and backfill and compact or grout burrows.					
Inspector Comment					
There are several large rodent holes in this area.

Looking at several rodent holes on landside slope.

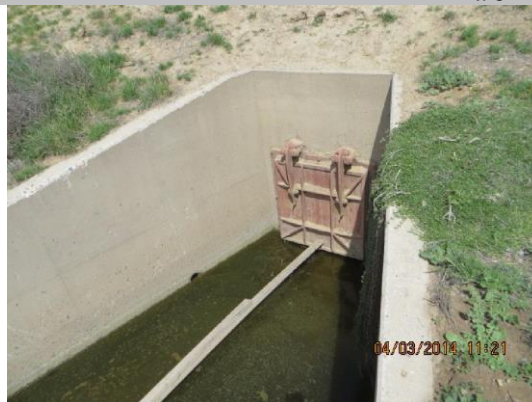
Photo 2 of 3 : UCIP_SP_2020_39542_59829.jpg

Flapgate on Concrete headwall on WS toe.

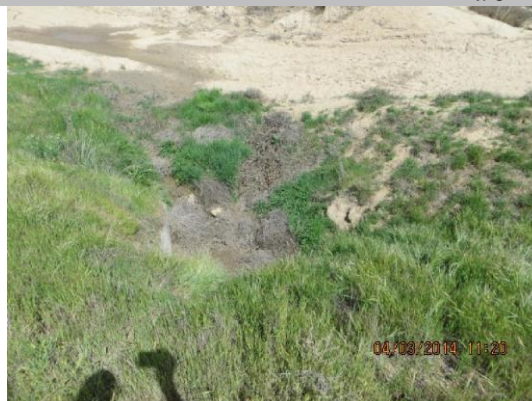
Photo 3 of 3 : UCIP_SP_2020_39542_59831.jpg

Concrete headwall at LS toe.

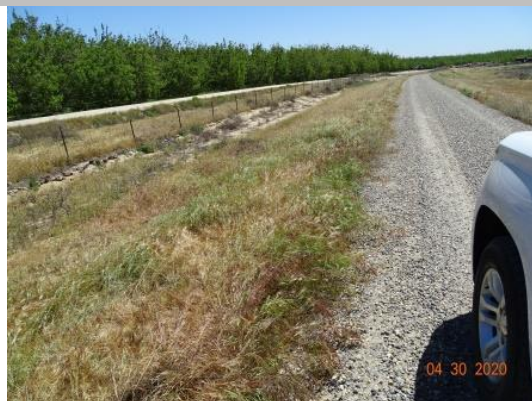
Photo 1 of 1 : SP_2020_NA0010_139_52_20200513_00044.jpg

LM Start	5.89	Rating **	U	Issue No.	52
LM End	9.39	Issue Type +	Ma	Location *	LS
Category	Earthen Levee			GPS Latitude/Longitude	
				Start	End
Item	Vegetation			36.790997 °	36.804152 °
				-120.202742 °	-120.171146 °
DWR ID	DWR_NA0010_23_s_2020_52				
Comment Code					
V1 : Control annual grass and weeds on the levee slopes and easements.					
Inspector Comment

Looking upstream along the landside slope. (Spring 2020)

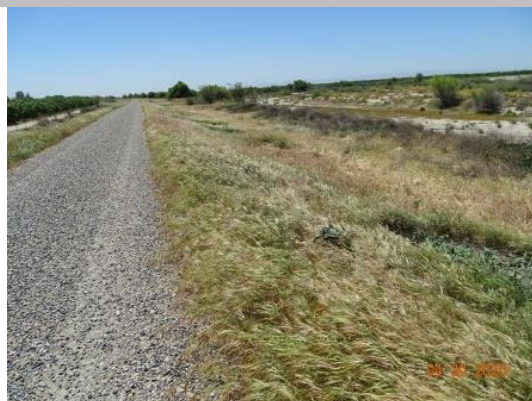
Photo 1 of 1 : SP_2020_NA0010_139_51_20200513_00045.jpg

LM Start	6.25	Rating **	U	Issue No.	51
LM End	9.39	Issue Type +	Ma	Location *	WS
Category	Earthen Levee			GPS Latitude/Longitude	
				Start	End
Item	Vegetation			36.786543 °	36.804152 °
				-120.200872 °	-120.171146 °
DWR ID	DWR_NA0010_23_s_2020_51				
Comment Code					
V1 : Control annual grass and weeds on the levee slopes and easements.					
Inspector Comment

View of the waterside slope looking upstream. (Spring 2020)

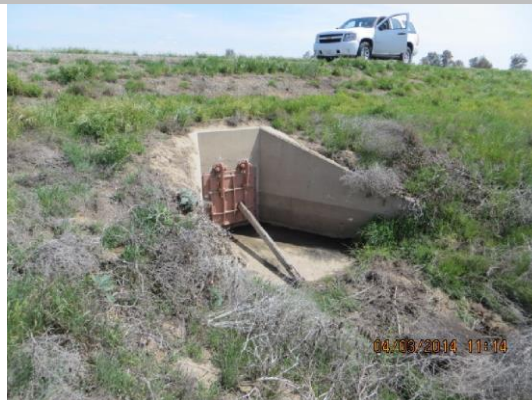
Photo 2 of 3 : UCIP_SP_2020_39543_59828.jpg

Flapgate on Concrete headwall at WS toe.

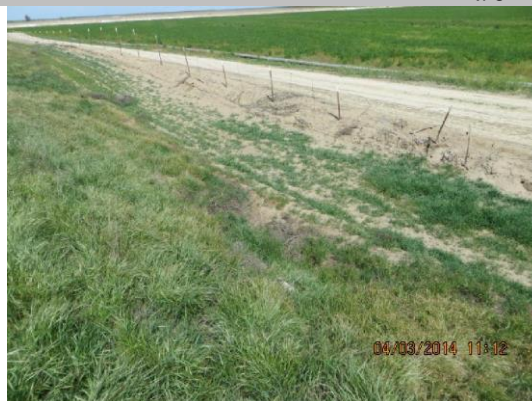
Photo 3 of 3 : UCIP_SP_2020_39543_59827.jpg

Concrete headwall on LS toe.

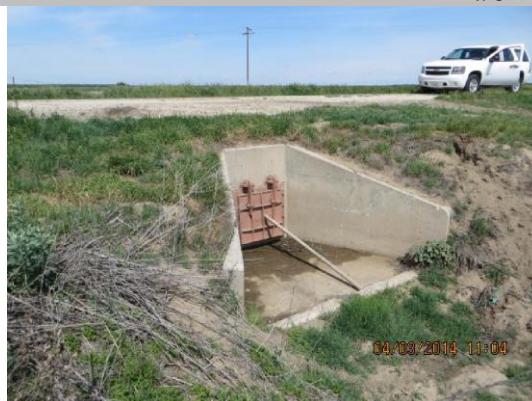
Photo 1 of 3 : UCIP_SP_2020_39544_59823.jpg

DS_ID:19940
FS_ID:39544
EP_NO: N/A
Repair Type: Non-Urgent
Crossing Status: Found
UCIP Comments: 04/03/2014 Some sediment buildup at inlet at LS toe. Also dense vegetation limits the inspector's visibility to identify signs of pipe failure (leaks) along the landward slope. Recommend removing vegetation along pipe alignment to conduct proper inspection of structure. (DWR UCIP - W. Wylie)
FIELD_STRUCT_DESC: 30-inch by 30-inch square reinforced concrete box gravity drainage culvert through the levee, 5.2 feet below the crown. Flap gate on the waterside (WS) end. Concrete headwall on the landside (LS) end. Concrete U-shaped headwall on the WS end.
[Additional Reference(s): DWR Levee Log, 2002. USACE San Joaquin O&M Manual 601.1, 1967, (HLM 8.33)].
FS Date: 4/3/2014

Flapgate on WS toe.

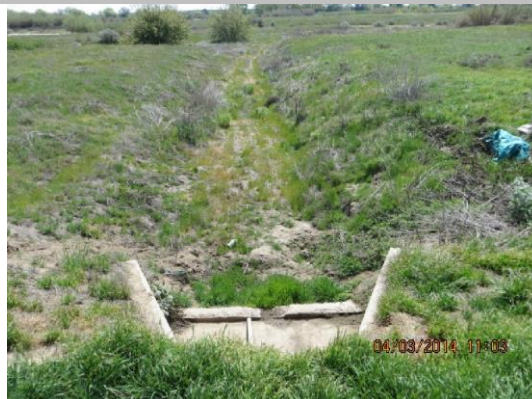
Photo 2 of 3 : UCIP_SP_2020_39544_59821.jpg

cocrete headwall at drainage ditch on WS toe.

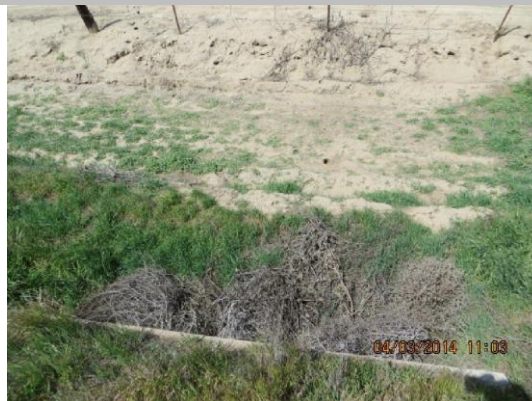
Photo 3 of 3 : UCIP_SP_2020_39544_59822.jpg

Concrete headwall on LS toe.

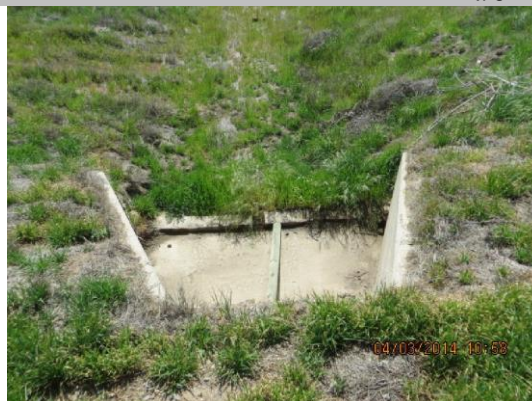
Photo 1 of 3 : UCIP_SP_2020_39545_59817.jpg

Comment Code						
Inspector Comment						
DS_ID:19941 FS_ID:39545 EP_NO: N/A Repair Type: Non-Urgent Crossing Status: Found UCIP Comments: 04/03/2014 Dense vegetation limits the inspector's visibility to identify signs of pipe failure (leaks) along the landward slope. Recommend removing vegetation along pipe alignment to conduct proper inspection of structure. (DWR UCIP - W. Wylie) FIELD_STRUCT_DESC: 30-inch by 30-inch square reinforced concrete box gravity drainage culvert through the levee, 5.6 feet below the crown. Flap gate on the waterside (WS) end. Concrete headwall on the landside (LS) end. Concrete U-shaped headwall on the WS end. [Additional Reference(s): DWR Levee Log, 2002. USACE San Joaquin O&M Manual 601.1, 1967, (HLM 8.54)]. FS Date: 4/3/2014

Concrete headwall on WS toe.

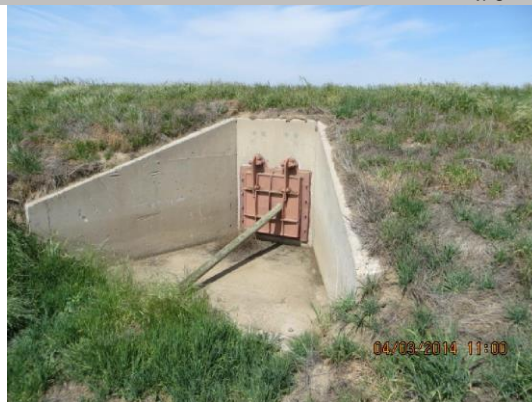
Photo 2 of 3 : UCIP_SP_2020_39545_59819.jpg

Flapgate on Concrete headwall at WS toe.

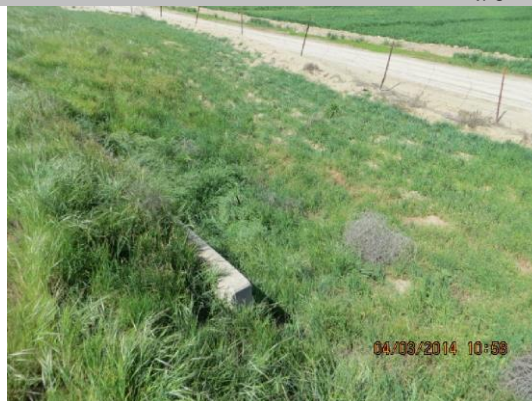
Photo 3 of 3 : UCIP_SP_2020_39545_59818.jpg

Concrete headwall on LS toe.

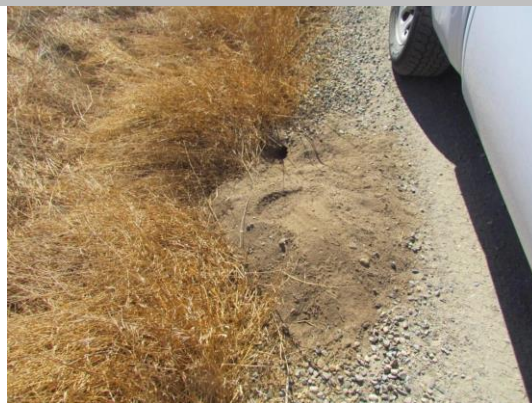
Photo 1 of 1 : SP_2020_NA0010_139_25_20200225_00005.jpg

LM Start	8.97	Rating **	M	Issue No.	25
LM End	8.97	Issue Type +	Ma	Location *	WS
Category	Earthen Levee			GPS Latitude/Longitude	
				Start	End
Item	Animal Control			36.799606 °	36.799606 °
				-120.175395 °	-120.175395 °
DWR ID	DWR_NA0010_23_f_2016_25				
Comment Code					
A3 : No rodents visible, but rodent burrows visible; need to backfill and compact or grout burrows.					
Inspector Comment					
There are rodent holes on the waterside shoulder.

Looking at typical view of rodent hole on waterward shoulder.

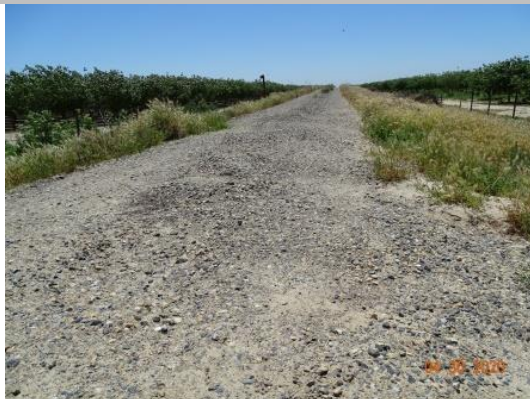
Photo 1 of 1 : SP_2020_NA0010_139_65_20200513_00046.jpg

LM Start	9.74	Rating **	M	Issue No.	65
LM End	9.74	Issue Type +	Ma	Location *	CR
Category	Earthen Levee			GPS Latitude/Longitude	
				Start	End
Item	Crown Surface / Depressions / Rutting			36.807603 °	36.807603 °
				-120.168825 °	-120.168825 °
DWR ID	DWR_NA0010_23_s_2019_65				
Comment Code					
C2 : Repair depressions or ruts in the crown or slope.					
Inspector Comment

Depressions forming in the levee crown. (Spring 2020)

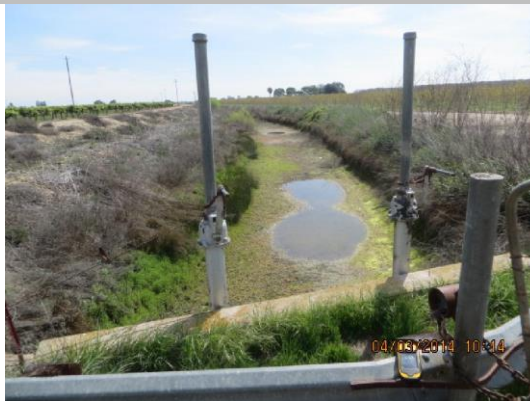
Photo 1 of 3 : UCIP_SP_2020_53192_59810.jpg

LM Start	9.75	Rating **	M	Issue No.	74
LM End	9.75	Issue Type +	En	Location *	
Category	Supplemental			GPS Latitude/Longitude	
				Start	End
Item	DWR UCIP Field Study			36.807768 °	36.807768 °
				-120.168848 °	-120.168848 °
DWR ID	19943

Comment Code					
Inspector Comment					
DS_ID:19943 FS_ID:53192 EP_NO: N/A Repair Type: Non-Urgent Crossing Status: Found UCIP Comments: 11/01/2018 Limited access to both LS and WS; assumed slide gates are still non-functional; Crossing has been downgraded from Urgent to Non-Urgent due to re-classification of damage slide gates. (O. Magana - DWR UCIP)07/20/2016 No change--same as previous inspection. (DWR UCIP - omagana)04/03/2014 Slide gate not functional. Slide gate channels heavily corroded (exfoliated) and likely impact functionality/structural integrity of gate. (DWR UCIP - wwylie) FIELD_STRUCT_DESC: [Gravelly Ford Canal Irrigation Structure] 1 of 2: 48-inch by 63-inch reinforced concrete box gravity irrigation culvert through the levee, 10 feet below the crown. Concrete U-shaped headwall on each end. Gear pedestal slide gate with wall bracket on the waterside (WS) headwall. 10-foot-long cobble revetted outlet channel. Guardrail on each shoulder. Slide gates on the WS. [Additional Reference(s): DWR Levee Log, 2002. USACE San Joaquin O&M Manual 601.1, 1967, (HLM 9.76)]. FS Date: 11/1/2018 12:50:00 PM

Slide gate actuator visible on WS shoulder with concrete headwall.

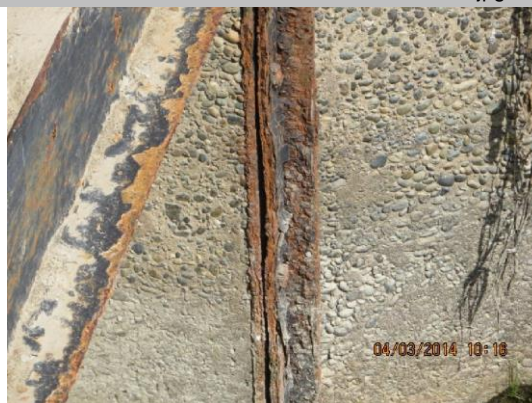
Photo 3 of 3 : UCIP_SP_2020_53192_59808.jpg

Heavy corrosion in slide gate tracks on WS toe.

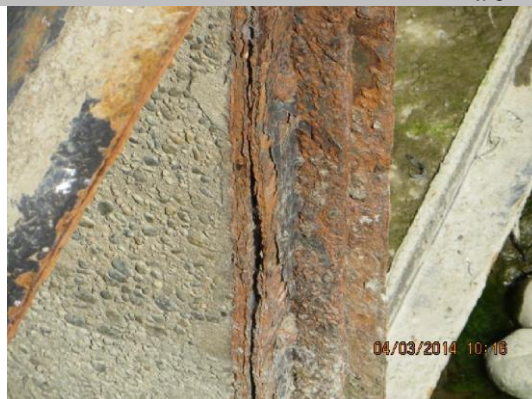
Photo 3 of 3 : UCIP_SP_2020_53193_59800.jpg

LM Start	9.75	Rating **	M	Issue No.	75 (cont)
LM End	9.75	Issue Type +	En	Location *	
Category	Supplemental		GPS Latitude/Longitude		
			Start	End	
Item	DWR UCIP Field Study		36.807777 °	36.807777 °	
			-120.168843 °	-120.168843 °	
DWR ID	19980

Slide gate tracks show heavy corrosion impacting actuation of slide gate.

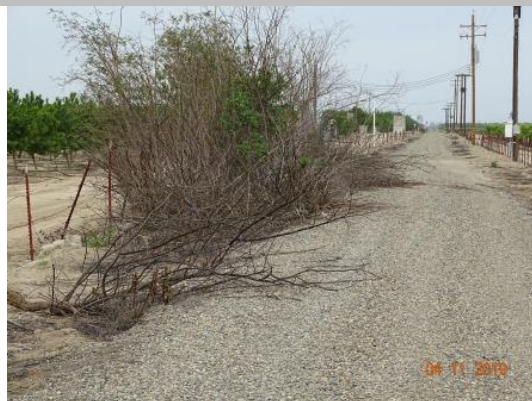
Photo 1 of 1 : SP_2020_NA0010_139_58_20200225_00013.jpg

LM Start	9.79	Rating **	M	Issue No.	58
LM End	9.81	Issue Type +	Ma	Location *	LS
Category	Earthen Levee			GPS Latitude/Longitude	
				Start	End
Item	Trim / Thin Trees			36.808317 °	36.808553 °
				-120.168820 °	-120.168827 °
DWR ID	DWR_NA0010_23_f_2018_58				
Comment Code					
T2 : Thin trees to allow visibility of the ground and room to flood fight.					
Inspector Comment					
Woody vegetation is partially blocking crown and landside slope.

Woody vegetation on landside toe obstructing landside of crown. (Spring 2019)

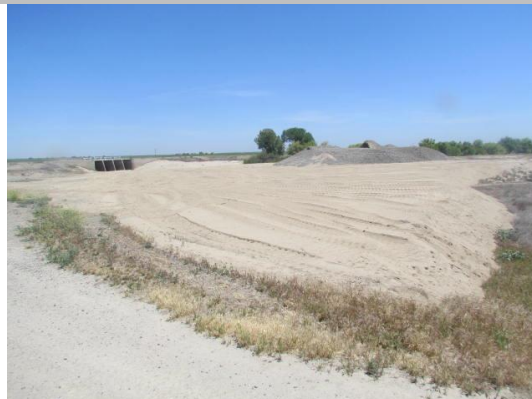
Photo 1 of 1 : SP_2020_NA0010_140_47_20200225_00010.jpg

LM Start	0.06	Rating **	M	Issue No.	47
LM End	0.06	Issue Type +	En	Location *	WS
Category	Earthen Levee			GPS Latitude/Longitude	
				Start	End
Item	Encroachments			36.772328 °	36.772328 °
				-120.285117 °	-120.285117 °
DWR ID	DWR_NA0010_24_s_2014_47				
Comment Code					
MA : Material					
Inspector Comment					
The District constructed a berm on waterside slope. The berm is being used for staging of earthen material.

Looking northeast at berm on waterward slope.

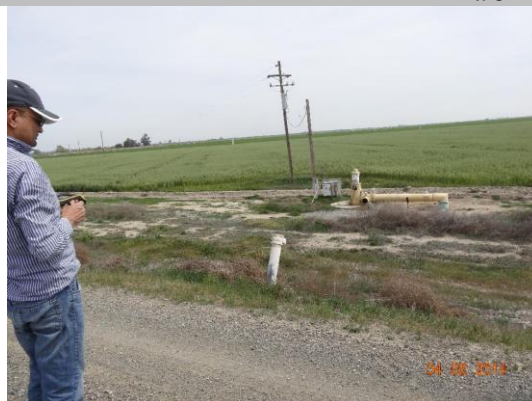
Photo 1 of 2 : UCIP_SP_2020_33265_60065.jpg

Comment Code						
Inspector Comment						
DS_ID:19961 FS_ID:33265 EP_NO: 13735 Repair Type: Non-Urgent Crossing Status: Found UCIP Comments: 04/08/2014 Unable to determine status of crossing. Need to contact owner to determine status of crossing. (DWR UCIP - O. Magana) FIELD_STRUCT_DESC: 24-inch coated steel drainage discharge pipe through the levee, 2 feet below the crown. Crown roadway has been padded 1 foot. Steel cutoff wall around the pipe at the centerline of the levee. Pump on the landside (LS). Siphon breaker on the apex of the pipe on the LS shoulder. Galvanized siphon vent pipe on the LS shoulder. (Plans to install two 24-inch steel discharge pipelines through the levee to dispose of seepage water collected in farm sumps Nos. 8 and 12 authorized under Permit No. 13735, 1983 - Rio Seco Farm). [Additional Reference(s): DWR Levee Log, 2002]. FS Date: 4/8/2014

View of landward side.

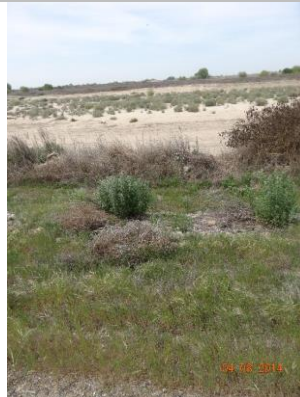
Photo 2 of 2 : UCIP_SP_2020_33265_60064.jpg

LM Start	1.06	Rating **	M	Issue No.	268 (cont)
LM End	1.06	Issue Type +	En	Location *	
Category	Supplemental		GPS Latitude/Longitude		
			Start	End	
Item	DWR UCIP Field Study		36.769574 °	36.769574 °	
			-120.276253 °	-120.276253 °	
DWR ID	19961

View of waterward side.

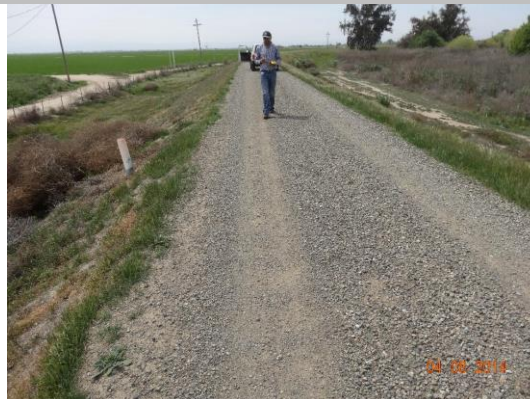
Photo 1 of 3 : UCIP_SP_2020_33266_60069.jpg

DS_ID:19962
 FS_ID:33266
 EP_NO: 13085
 Repair Type: Non-Urgent
 Crossing Status: Indicator Found
 UCIP Comments: 04/08/2014 Need to contact owner to determine status. (DWR UCIP - O. Magana)
 FIELD_STRUCT_DESC: 20-inch coated steel gravity drainage pipe through the levee, 2 feet below the crown. Pipe encased in concrete through the levee crown. Steel cutoff wall around the pipe at each shoulder. Siphon breaker installed on the apex of the pipe on the landside (LS) shoulder. Vent pipe on LS shoulder. Rock riprap on the waterside (WS) slope. (Plans to construct a new discharge structure and to rehabilitate one existing diversion structure to return intercepted seepage to the San Joaquin River authorized under Permit No. 13085, 1981 - Diener, Dry River Farms). [Additional Reference(s): DWR Levee Log, 2002].
 FS Date: 4/8/2014

Overview of levee crown at crossing.

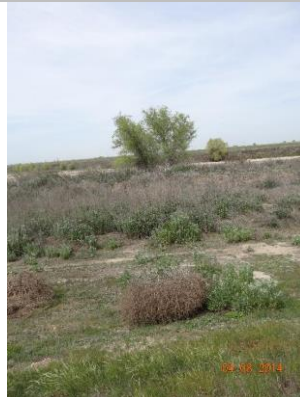
Photo 2 of 3 : UCIP_SP_2020_33266_60070.jpg

View of waterward side.

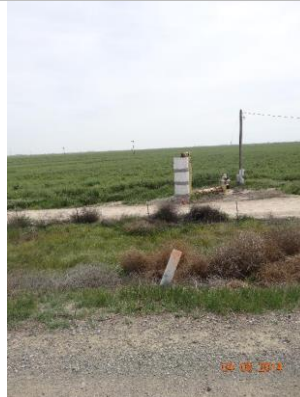
Photo 3 of 3 : UCIP_SP_2020_33266_60071.jpg

View of landward side.

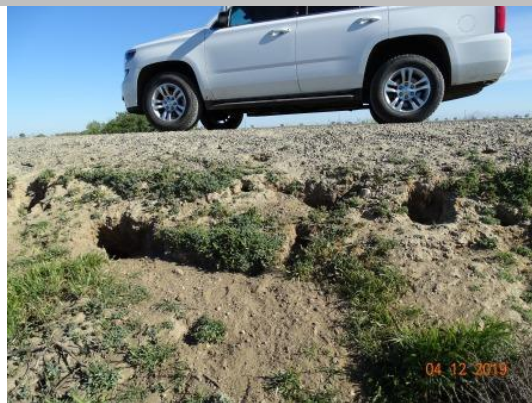
Photo 1 of 1 : SP_2020_NA0010_140_51_20200225_00012.jpg

LM Start	3.05	Rating **	U	Issue No.	51
LM End	3.15	Issue Type +	Ma	Location *	LS
Category	Earthen Levee			GPS Latitude/Longitude	
				Start	End
Item	Animal Control			36.770146 °	36.769870 °
				-120.245703 °	-120.243877 °
DWR ID	DWR_NA0010_24_s_2019_51				
Comment Code					
A3 : No rodents visible, but rodent burrows visible; need to backfill and compact or grout burrows.					
Inspector Comment

View of rodent holes in landside slope. (Spring 2019)

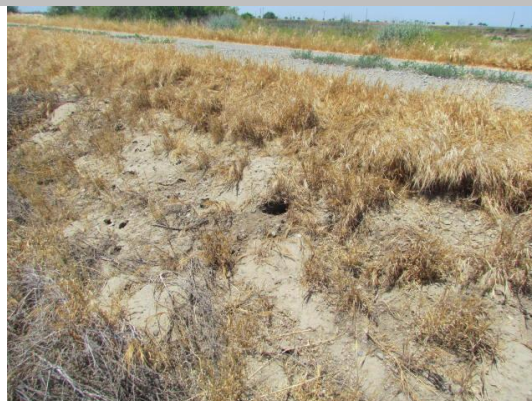
Photo 1 of 1 : SP_2020_NA0010_140_7_20200225_00002.jpg

LM Start	3.46	Rating **	M	Issue No.	7
LM End	3.46	Issue Type +	Ma	Location *	LS
Category	Earthen Levee			GPS Latitude/Longitude	
				Start	End
Item	Animal Control			36.769345 °	36.769345 °
				-120.238370 °	-120.238370 °
DWR ID	DWR_NA0010_24_s_2012_7				
Comment Code					
A3 : No rodents visible, but rodent burrows visible; need to backfill and compact or grout burrows.					
Inspector Comment					
There are several rodent holes on the landside slope.

Looking east at one of several rodent holes on landward slope.

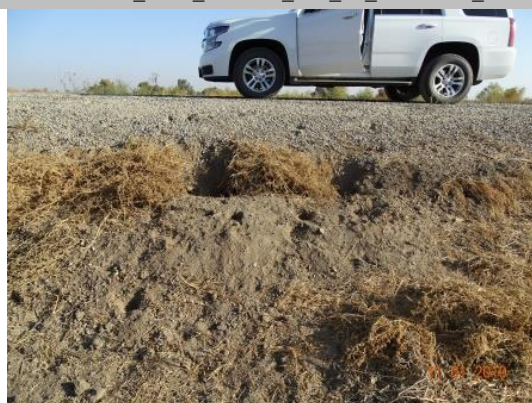
Photo 1 of 1 : SP_2020_NA0010_140_28_20200225_00008.jpg

LM Start	3.56	Rating **	M	Issue No.	28
LM End	3.59	Issue Type +	Ma	Location *	LS
Category	Earthen Levee			GPS Latitude/Longitude	
				Start	End
Item	Animal Control			36.768700 °	36.768531 °
				-120.236668 °	-120.236226 °
DWR ID	DWR_NA0010_24_f_2019_28				
Comment Code					
A3 : No rodents visible, but rodent burrows visible; need to backfill and compact or grout burrows.					
Inspector Comment

View of rodent burrows in the landside slope. (Fall 2019)

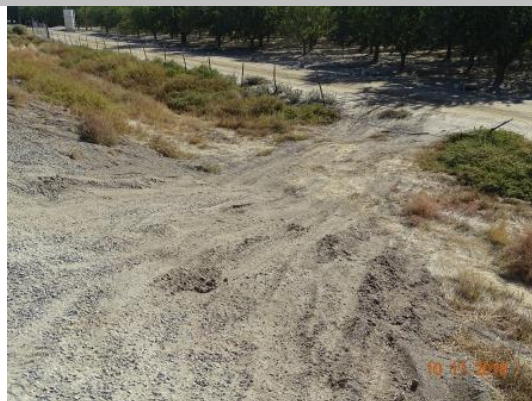
Photo 1 of 1 : SP_2020_NA0010_140_36_20200225_00009.jpg

LM Start	3.77	Rating **	M	Issue No.	36
LM End	3.77	Issue Type +	Ma	Location *	LS
Category	Earthen Levee			GPS Latitude/Longitude	
				Start	End
Item	Slope Stability			36.767784 °	36.767784 °
				-120.233252 °	-120.233252 °
DWR ID	DWR_NA0010_24_f_2018_36				
Comment Code					
S3 : Repair the levee slope damaged by vehicle traffic and prevent access where possible.					
Inspector Comment					
There is damage to the levee slope from vehicle traffic. The landowner appears to have removed a section of fencing to allow access at this location.

View of damage to slope from vehicle traffic. (Fall 2018)

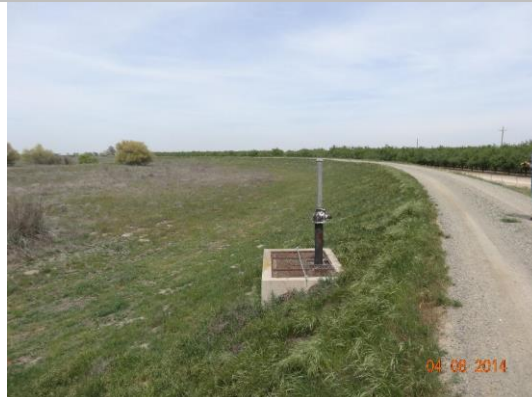
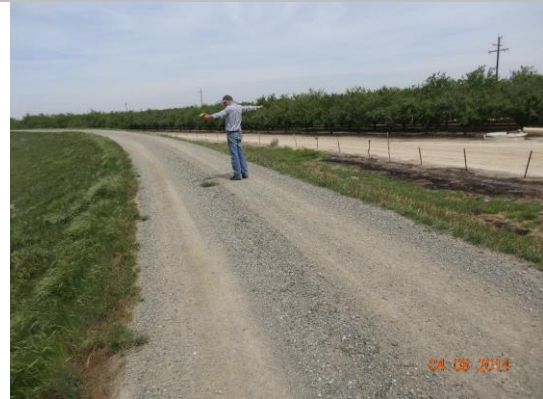
DS_ID:19964
FS_ID:36849
EP_NO: N/A
Repair Type: Non-Urgent
Crossing Status: Found
UCIP Comments: 04/08/2014 Unable to confirm crossing alignment and appurtenances associated with this crossing. Multiple stand pipes visible on landward side. Need to contact owner to determine status of crossing and alignment. (DWR UCIP - O. Magana)
FIELD_STRUCT_DESC: 30-inch by 30-inch square reinforced concrete box drainage discharge culvert through the levee, 12.5 feet below the crown. Pump on the landside (LS). Concrete riser with slide gate on the waterside (WS) slope. Screw gate on the LS shoulder. (Plans to construct a new discharge structure and to rehabilitate one existing diversion structure to return intercepted seepage to the San Joaquin River authorized under Permit No. 13085, 1981 - Diener, Dry River Farms). [Additional Reference(s): DWR Levee Log, 2002].
FS Date: 4/8/2014

View of waterward side.

Slide gate inside concrete box located on waterward side.

Overview of levee at crossing.

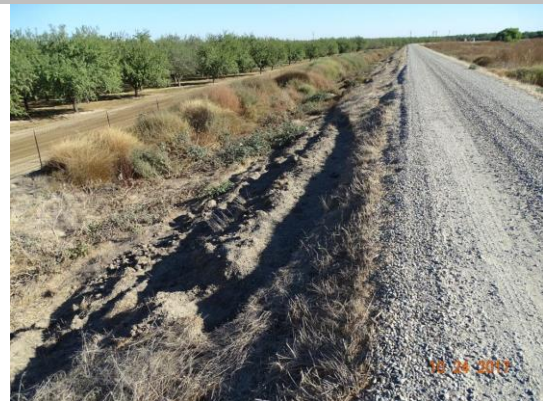
Photo 1 of 1 : SP_2020_NA0010_140_17_20200225_00005.jpg

LM Start	4.27	Rating **	M	Issue No.	17
LM End	4.27	Issue Type +	Ma	Location *	LS
Category	Earthen Levee			GPS Latitude/Longitude	
				Start	End
Item	Slope Stability			36.772003 °	36.772003 °
				-120.230075 °	-120.230075 °
DWR ID	DWR_NA0010_24_f _ 2017_17				
Comment Code					
S3 : Repair the levee slope damaged by vehicle traffic and prevent access where possible.					
Inspector Comment

Looking southeast at the landside slope.

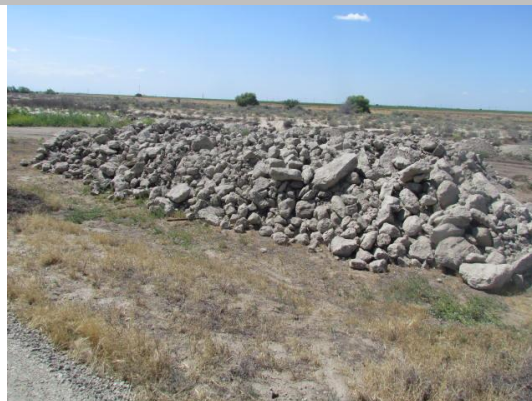
Photo 1 of 1 : SP_2020_NA0010_140_266_20200225_00014.jpg

LM Start	5.30	Rating **	M	Issue No.	266
LM End	5.30	Issue Type +	En	Location *	WS
Category	Earthen Levee			GPS Latitude/Longitude	
				Start	End
Item	Encroachments			36.781960 °	36.781960 °
				-120.224496 °	-120.224496 °
DWR ID	DWR_NA0010_24_s_2015_266				
Comment Code					
MA : Material					
Inspector Comment					
Rocks are stockpiled near the waterside toe.

Looking north at rock pile on waterward berm.

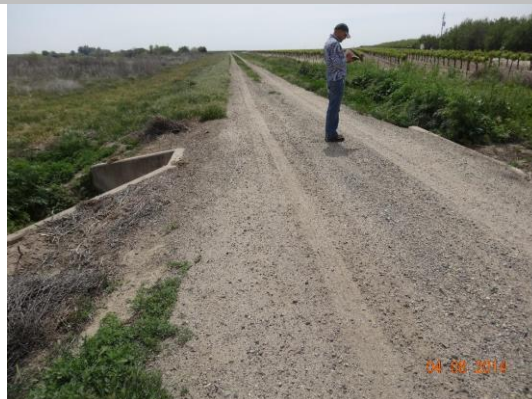
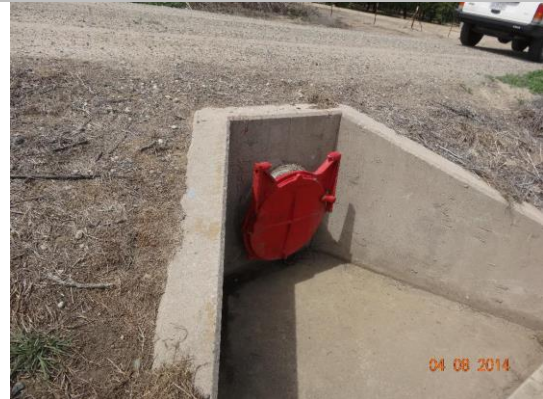
DS_ID:19957
FS_ID:50056
EP_NO: N/A
Repair Type: Non-Urgent
Crossing Status: Found
UCIP Comments: 7/20/2016 same as previous inspection. Crossing has been downgraded from Urgent to Non-Urgent PVC does not prevent WS flap gate from closing. (DWR UCIP - omagana)4/08/2014 Unauthorized PVC pipe through existng crossing. PVC distorted inside--Need to contact owner to correct issue. If crossing was allowed need to contact owner for permit number issue for crossing variance. (DWR UCIP - omagana)
FIELD_STRUCT_DESC: 24-inch corrugated metal gravity drainage pipe through the levee, 3.6 feet below the crown. Flap gate on the waterside (WS) end. Concrete headwall on the landside (LS) end. Concrete U-shaped headwall on the WS end. [Additional Reference(s): DWR Levee Log, 2002].
FS Date: 7/20/2016

Overview of levee crown at crossing.

View of WS--debris (pipe sections) located on waterward side.

Flap gate visible on WS.
